TASK FORCE - OPERATION OIL

(Clean-up of the Arrow oil spill
in Chedabucto Bay)

The Minister of Transport

VOLUME IV

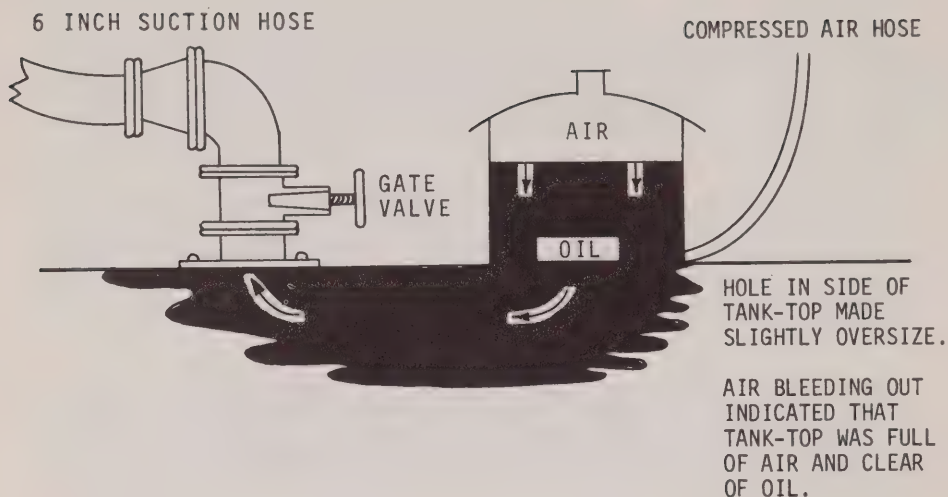
1. Compressed Air

By introducing compressed air into the tank top the residual oil was forced out below the deck and pumped in the normal way. This worked reasonably well, but it was found that all the oil would not reach the suction, with the result that when the air bled out of the tank top this oil would re-enter the tank top. This situation was not satisfactory so another method was tried.

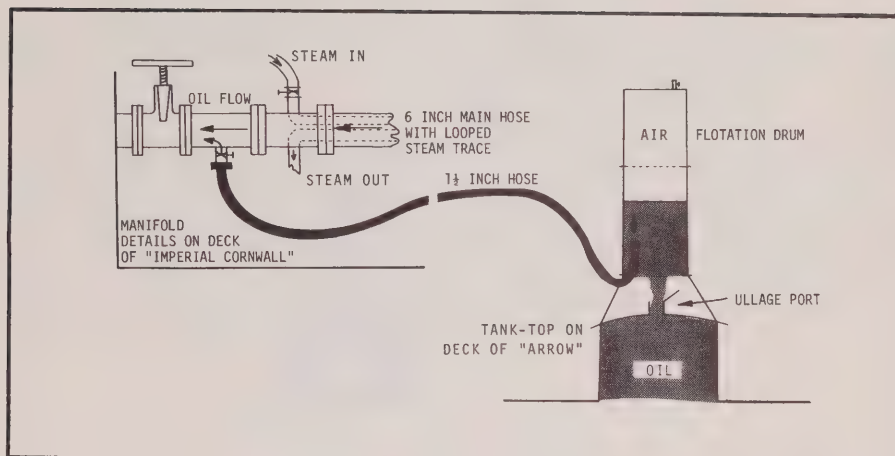
2. Syphon Effect

For this method an open-ended 45 gallon drum was attached to the tank top in an inverted position and kept vertical by a flotation barrel. The end of a one and a half inch bore hose was placed inside the drum and the other end was attached to the suction manifold of the "IMPERIAL CORNWALL". The theory behind this was that oil would be released into the drum by a diver opening the ullage cap until the drum was full and the suction on the main 6 inch hose (not necessarily attached to the tank being stripped), would syphon oil from the drum up the 1 1/2" line. This did work in practice despite the small bore of the hose and the viscosity of the oil, but was an extremely slow process. Accordingly, this method was also discontinued.

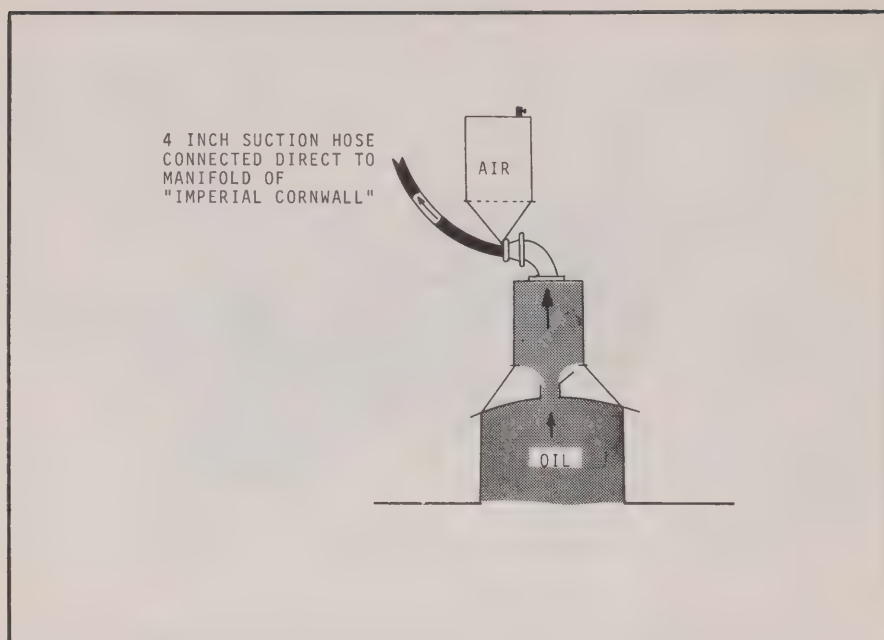
3. Direct Pumping

Amongst the equipment carried aboard "IMPERIAL CORNWALL" for her own account were found several lengths of 4" light-weight hose. A 90 degree elbow and reducing flange was attached to an open-ended oil drum and one end of the 4" hose attached to the flange, the other end being bolted direct to the suction manifold via another reducing flange. The drum assembly was then secured over the tank-top with a flotation barrel and oil released into it by a diver as before. This method worked well, and was utilized until all tank-tops had been stripped, despite the fact that it was a very messy, clumsy process, resulting in some spillage. Also, the frequent shifting from one tank to another was exhausting and frustrating for the divers.

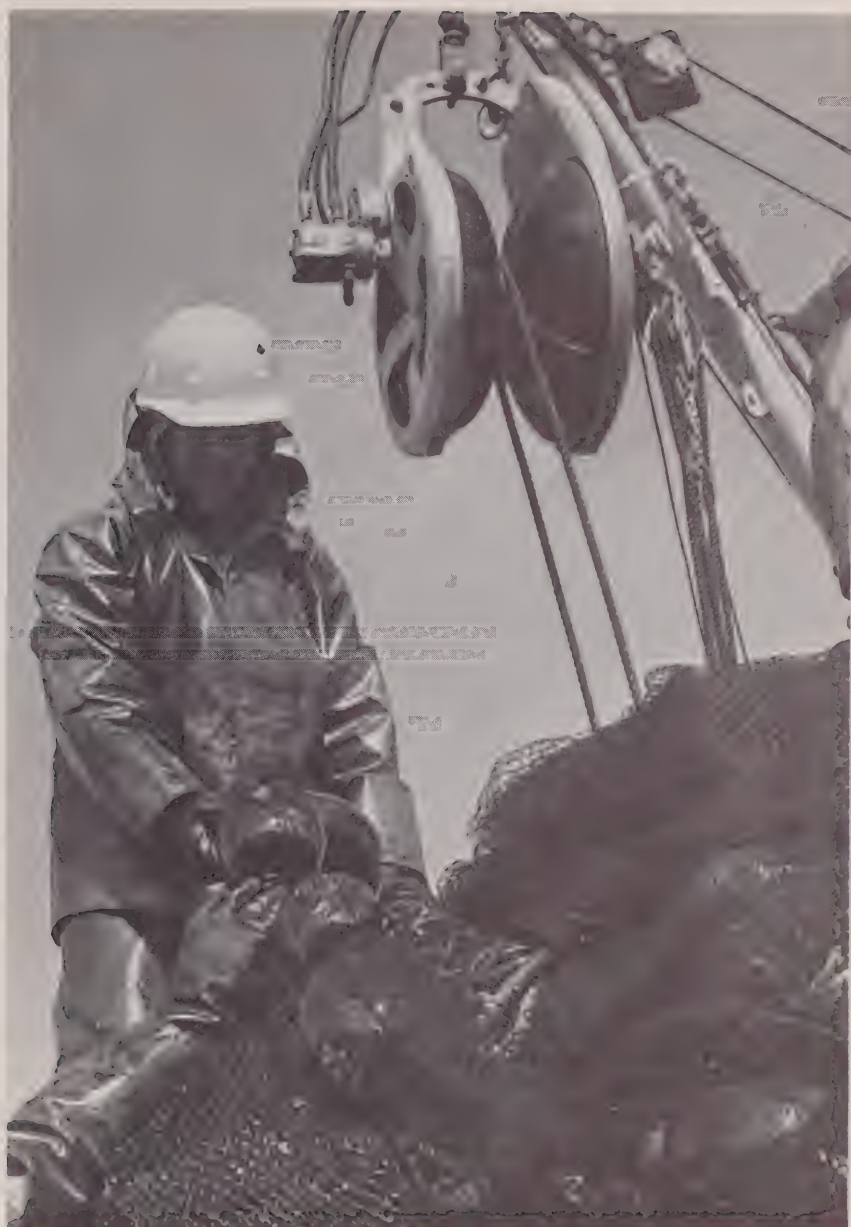
Net floats heavily contaminated with Bunker "C". The Marco Power Block used on herring seiner, PIERRE HELENE, showing cleated sheave. **O-401**

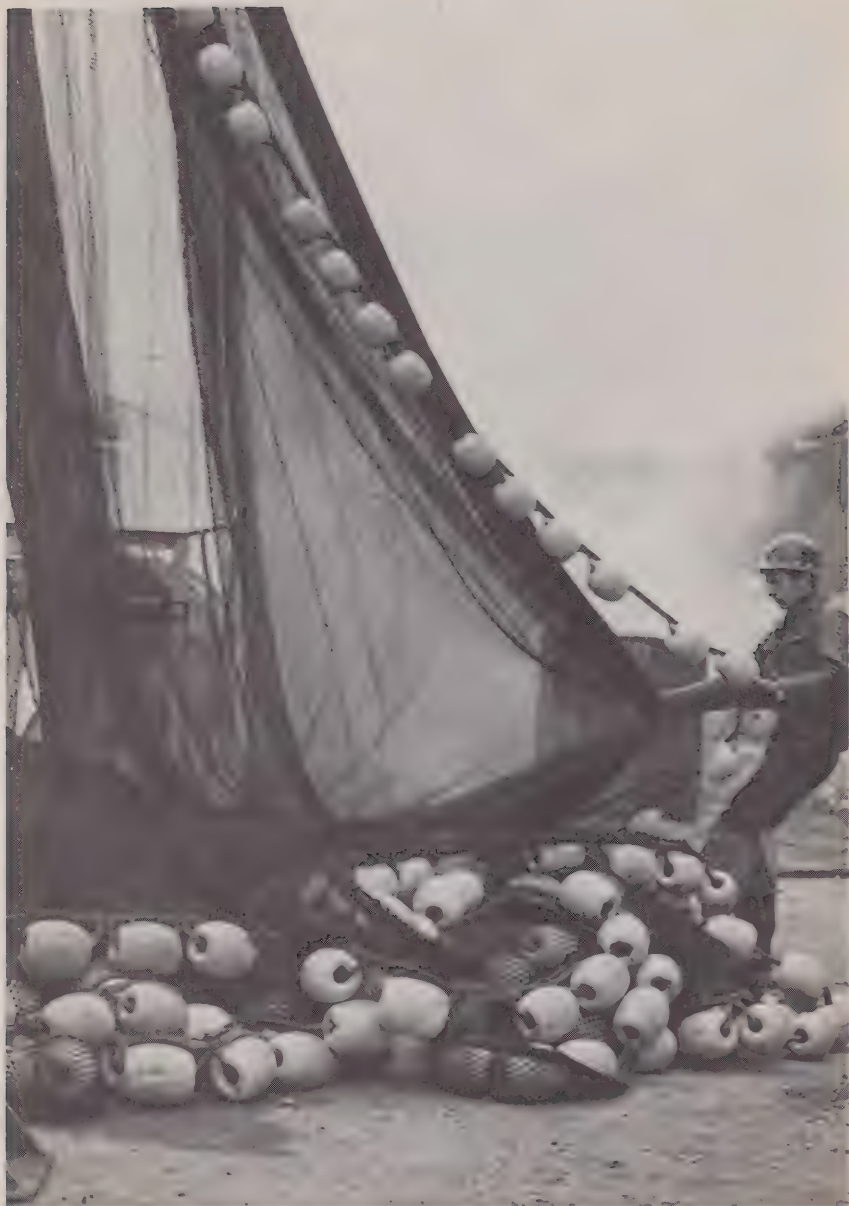
Crew member from seiner **PIERRE HELENE** piling the net as it comes from the power block during operation. Whiteness of floats proves efficiency of cleaning operation.
